**HYDRAULIC MODEL  
INVESTIGATION**

**TECHNICAL REPORT NO. 171-1**

**Applegate Dam Spillway  
and Outlet Works  
Applegate River, Oregon**

**CONDUCTED BY  
DIVISION HYDRAULIC LABORATORY  
U. S. ARMY CORPS OF ENGINEERS  
NORTH PACIFIC DIVISION  
BONNEVILLE, OREGON**

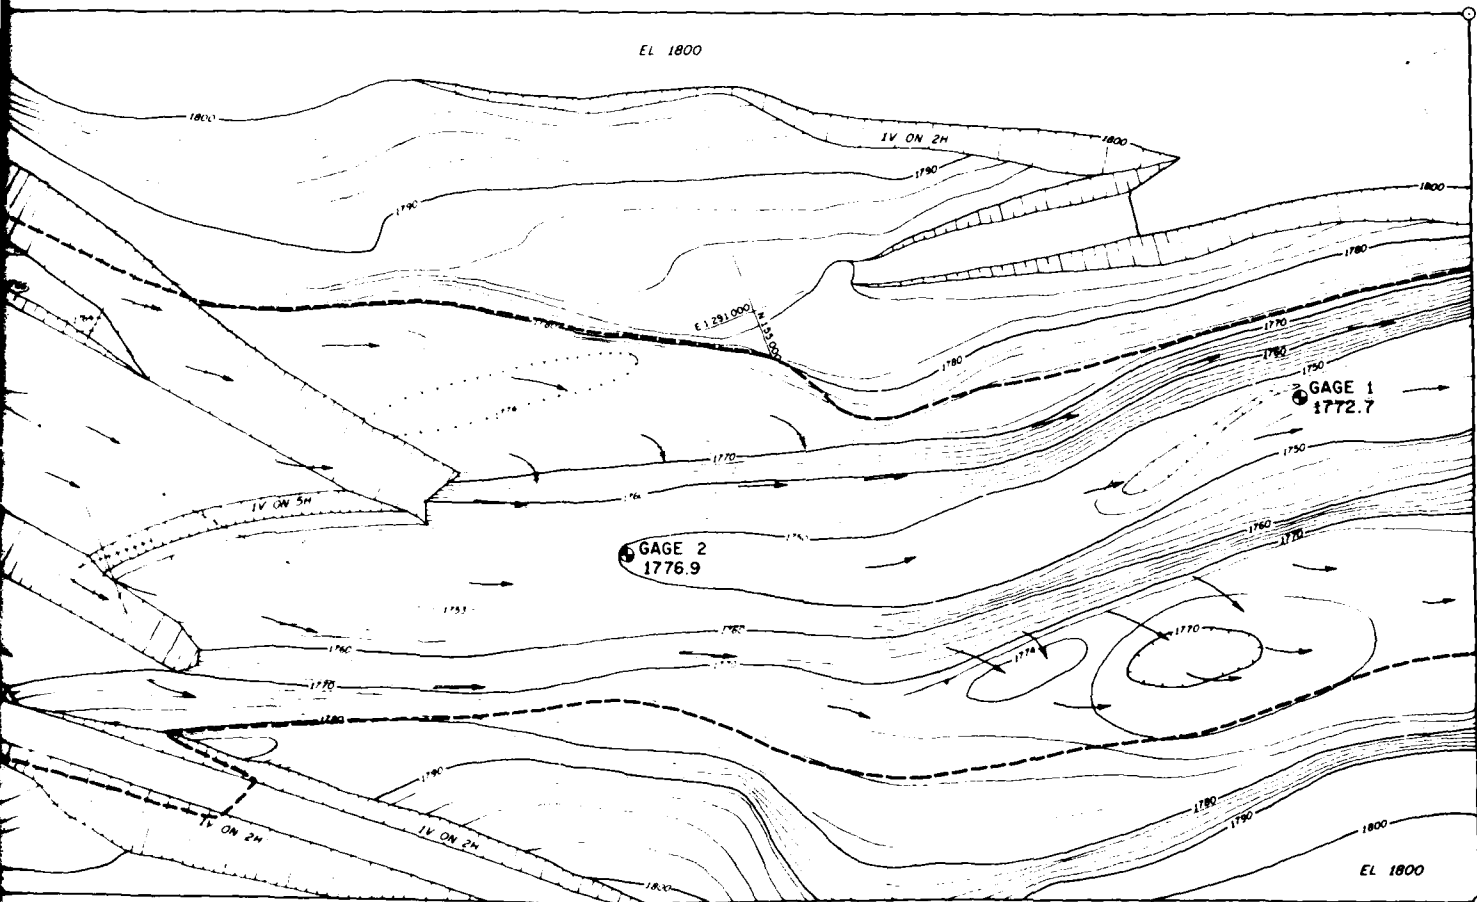
PLAN B PLUNGE POOL

FLOW CONDITIONS  
 SPILLWAY CHANNEL  
 RIVER DISCHARGE 49 800 CFS

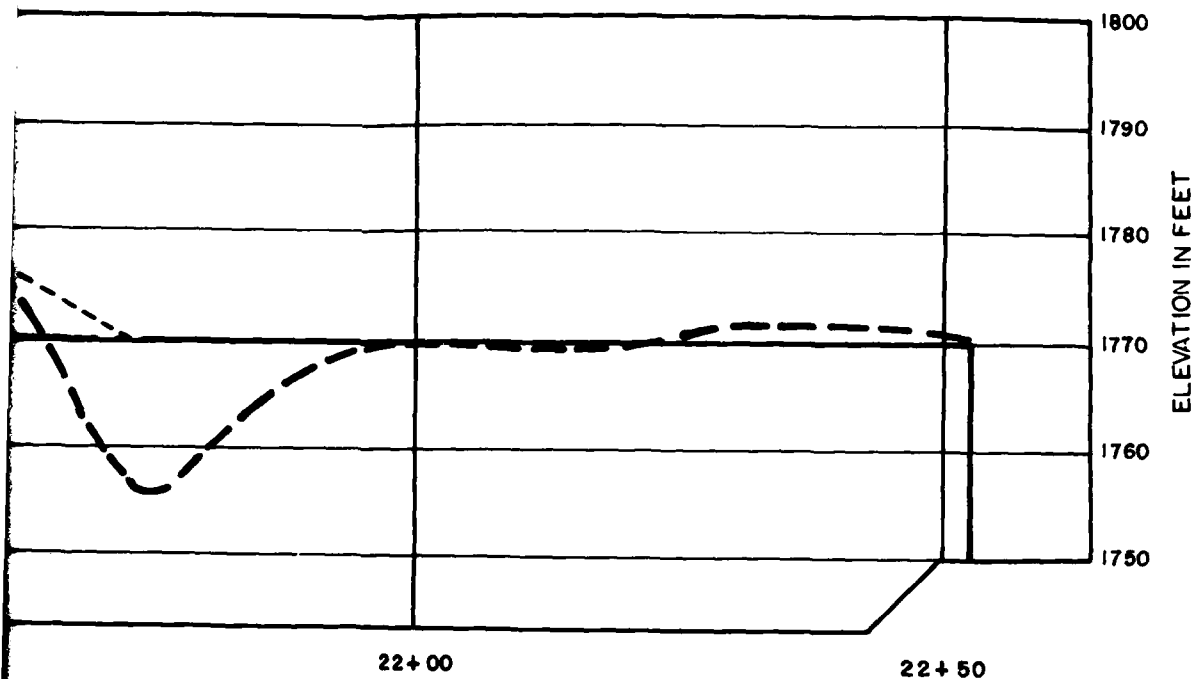
MAXIMUM WATER SURFACE PROFILE  
STILLING BASIN WALLS

DISCHARGE 6100 CFS  
CONDUIT ROUGHNESS  $K_s = 0.0002$  FEET

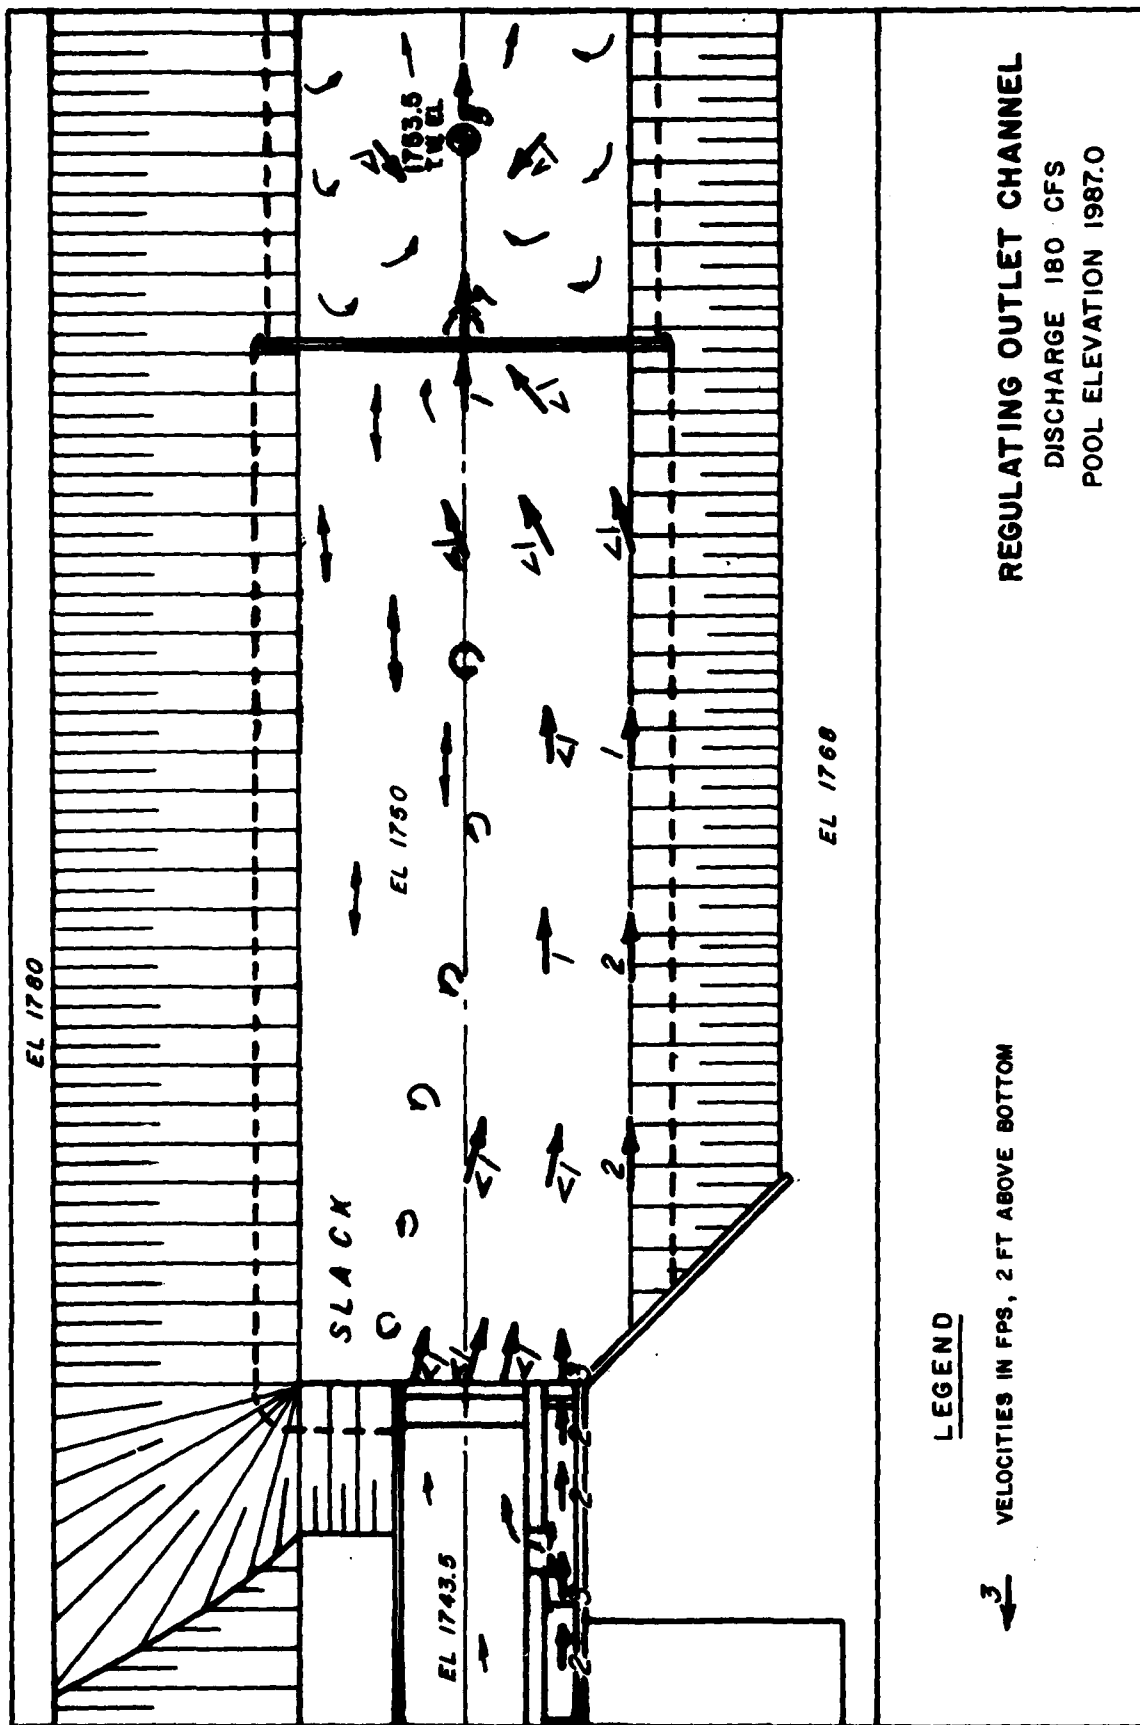
PLATE 34

DISCHARGE 6100 CFS

**POOL ELEVATION 1987.0**

35. The channel downstream from the stilling basin (see photograph 7) had an 80-foot bottom width. Flow conditions downstream from the secondary stilling basin with discharges of 180, 500, 1,000, 2,000, 4,500, and 6,100 cfs are shown on plates 34 to 39. Although eddies and upstream flow occurred along the left bank at all discharges, there was no tendency for sand or gravel to move into the basin. Material artificially placed in the basin was swept out as soon as velocities were high enough to move it. Flow conditions along the right bank were good for fish attraction with a path of downstream velocities ranging from 1 to 8 fps for the discharges tested. Photograph 50 shows the flow condition with a discharge of 6,100 cfs. In an attempt to eliminate the large eddy or slack water area along the left bank, the bank was filled to narrow the channel to a width of 60 feet (photograph 51). Slack water was eliminated, and the size of the eddy was reduced. A small eddy still occurred at the downstream end of the left training wall (plates 40 to 44), and although material was not carried into the basin from this eddy, good fish attraction conditions along the right bank were lost (photograph 52). Upstream or fluctuating flow occurred along the bank for all but the minimum flow (fishway attraction flow only). Although good downstream flow occurred farther out in the channel directly downstream from the fishway entrance this plan was discarded because flow along the channel bank was not adequate for fish attraction.

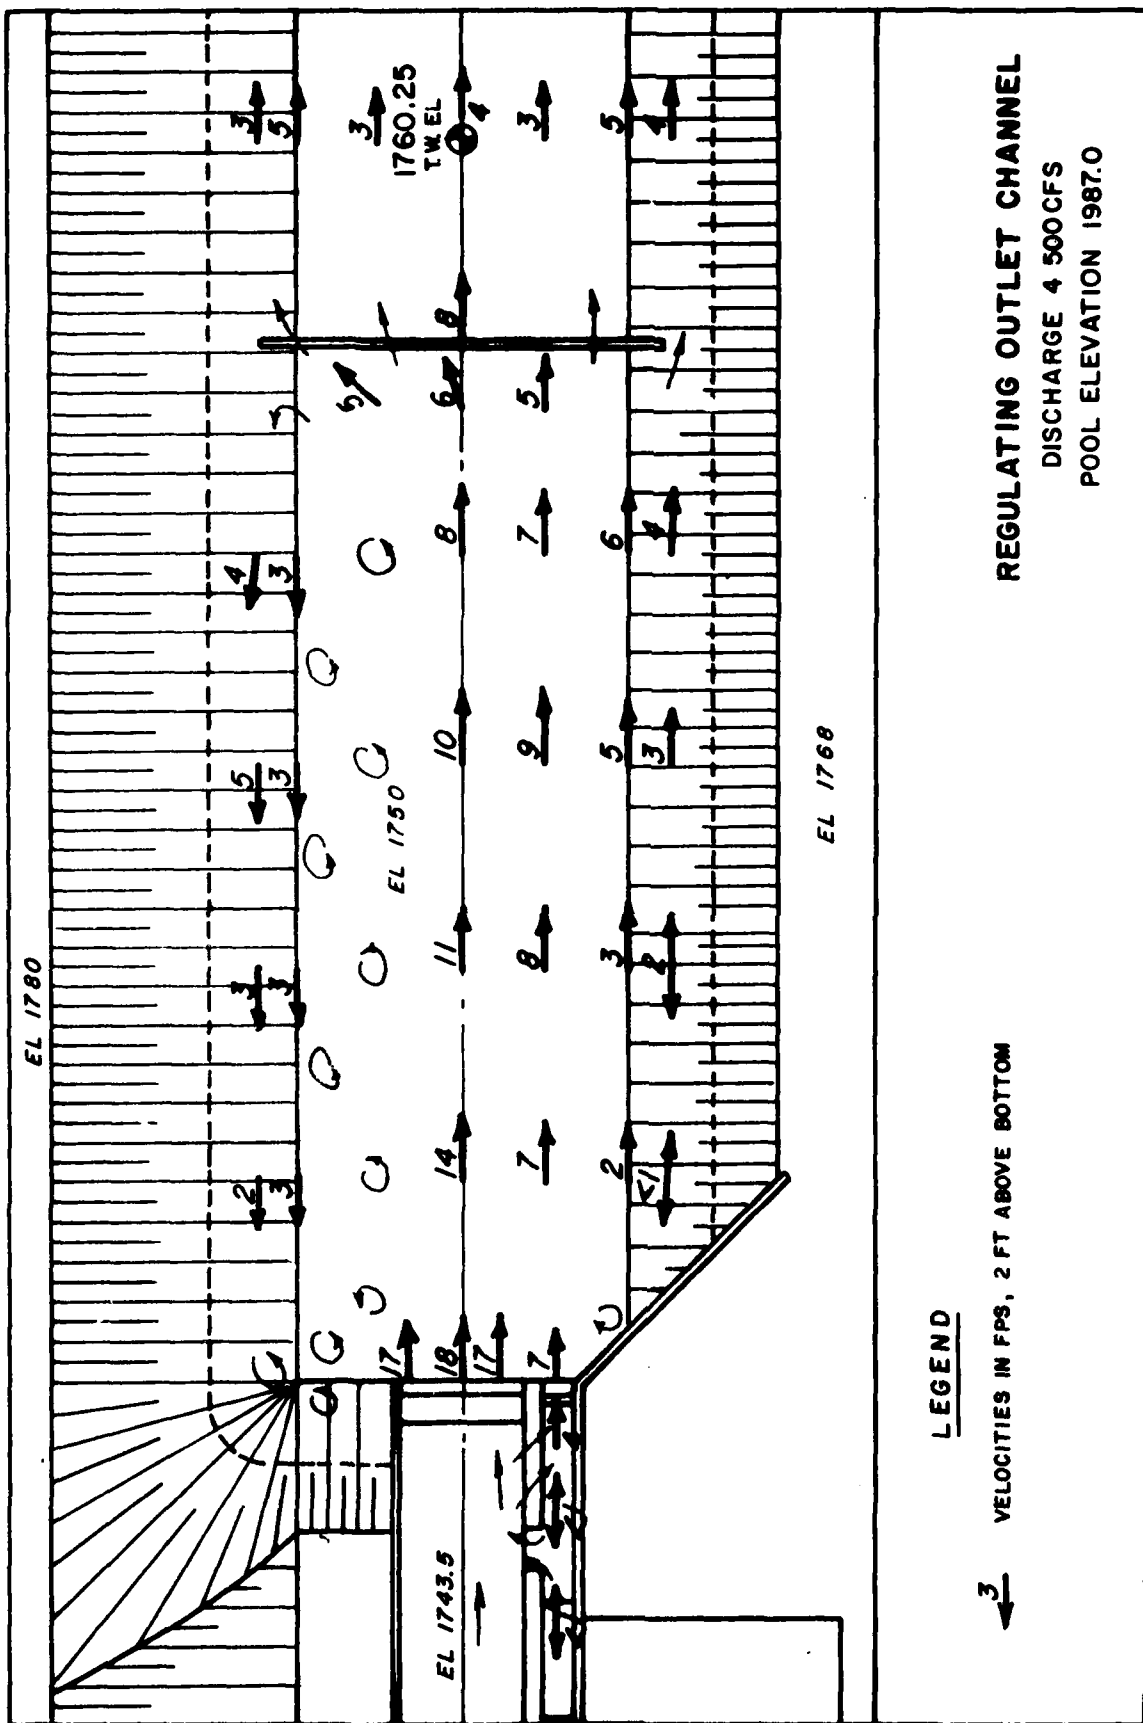
PLATE 38

## REGULATING OUTLET CHANNEL

DISCHARGE 2 000 CFS  
POOL ELEVATION 1987.0

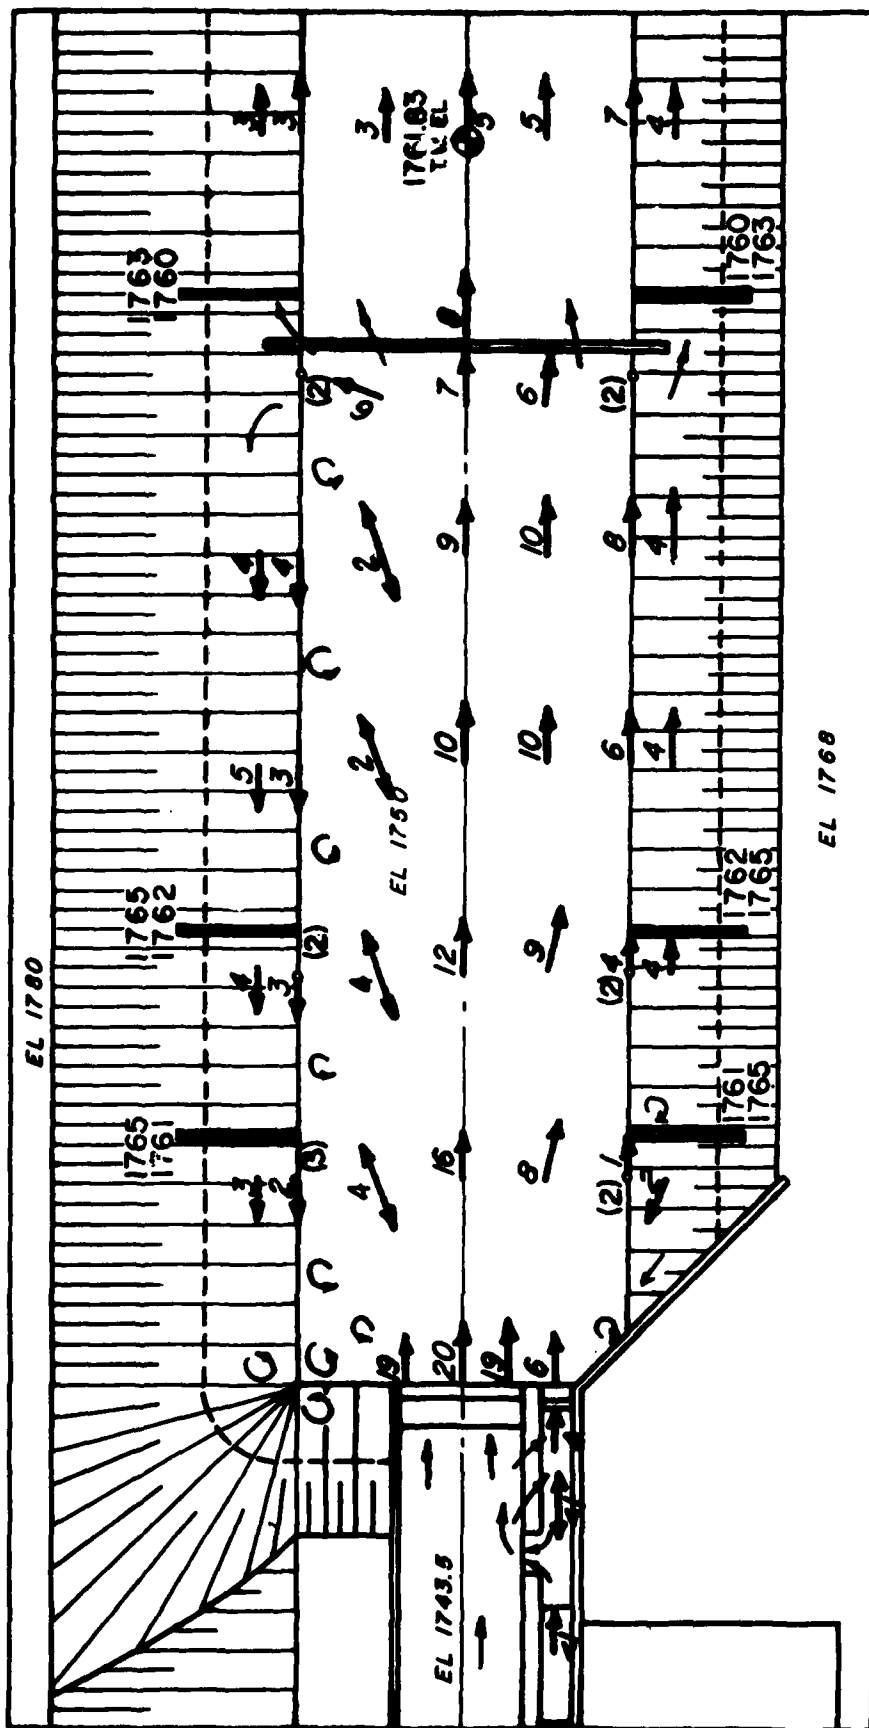
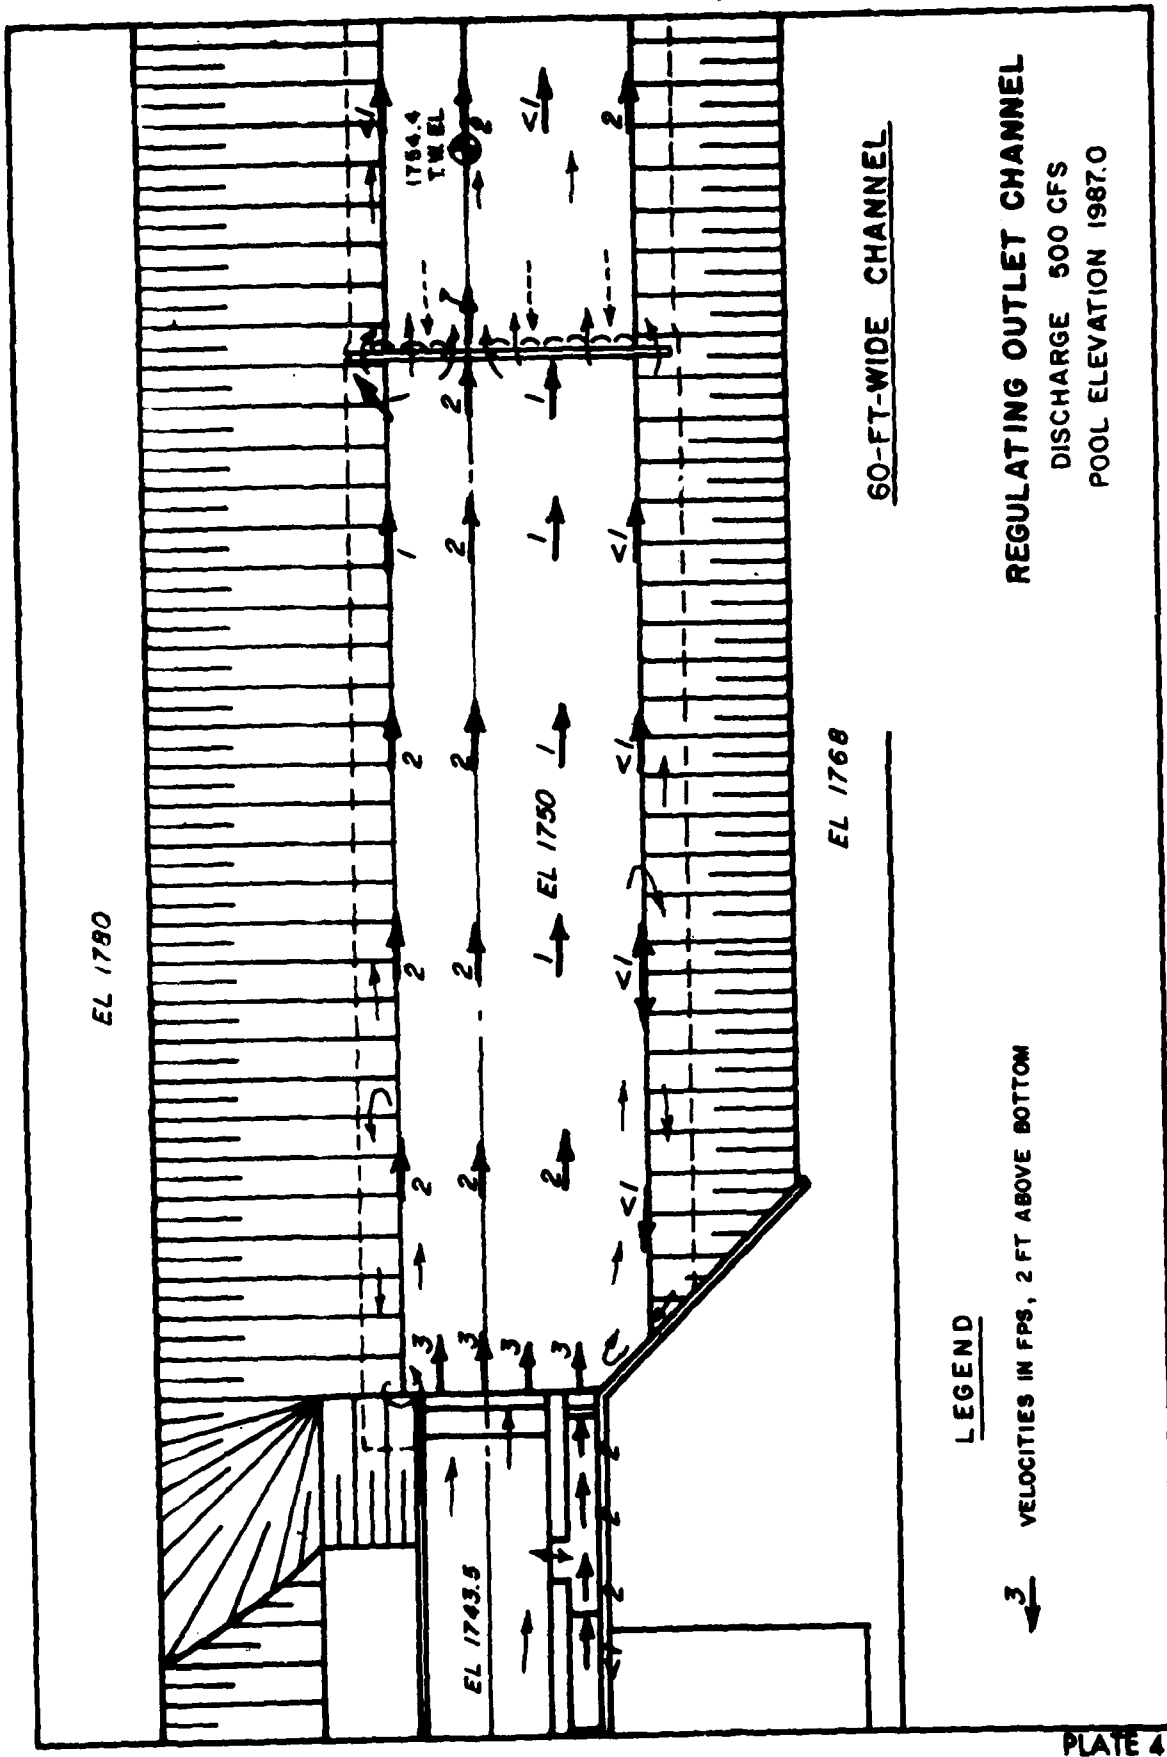
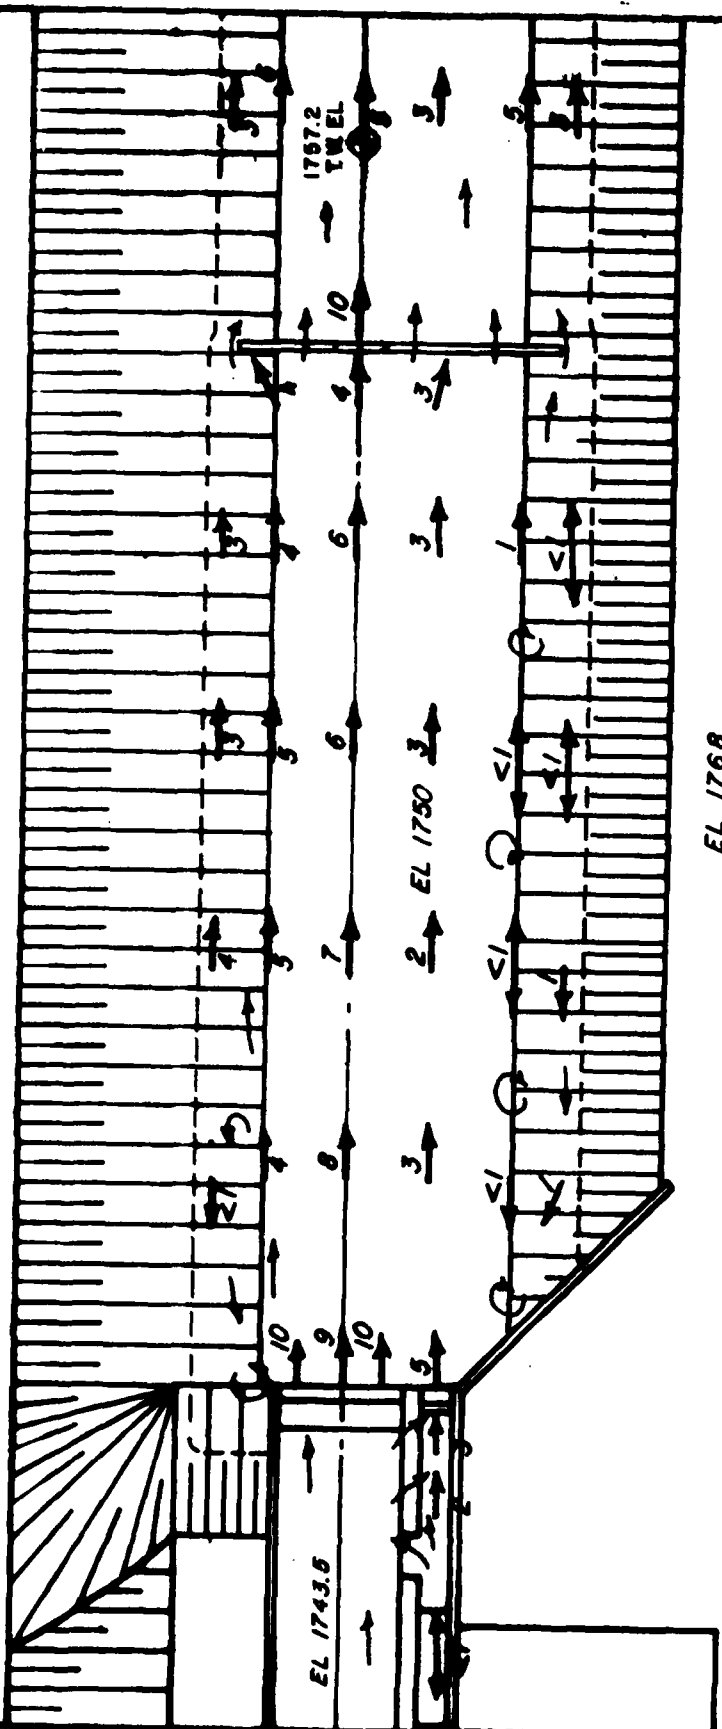
**REGULATING OUTLET CHANNEL**  
**DISCHARGE 180 CFS**  
**POOL ELEVATION 1987.0**

**60-FT-WIDE CHANNEL**

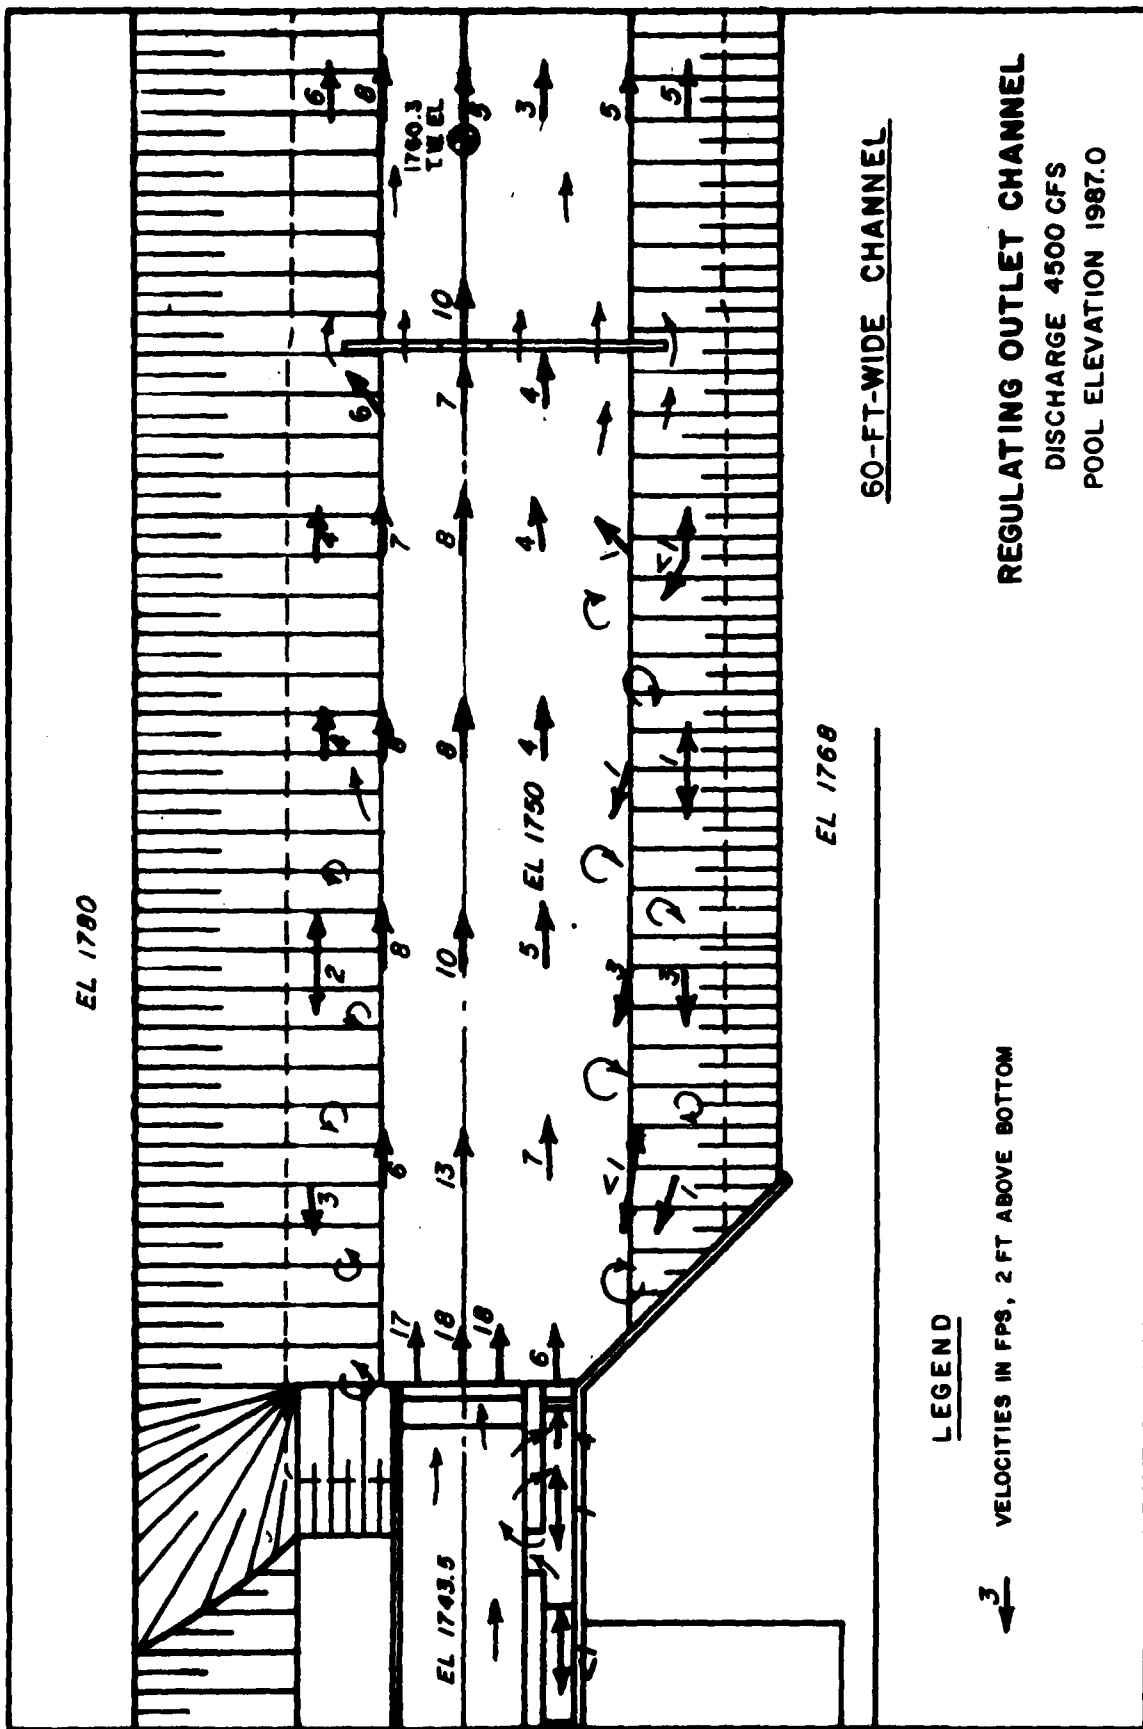
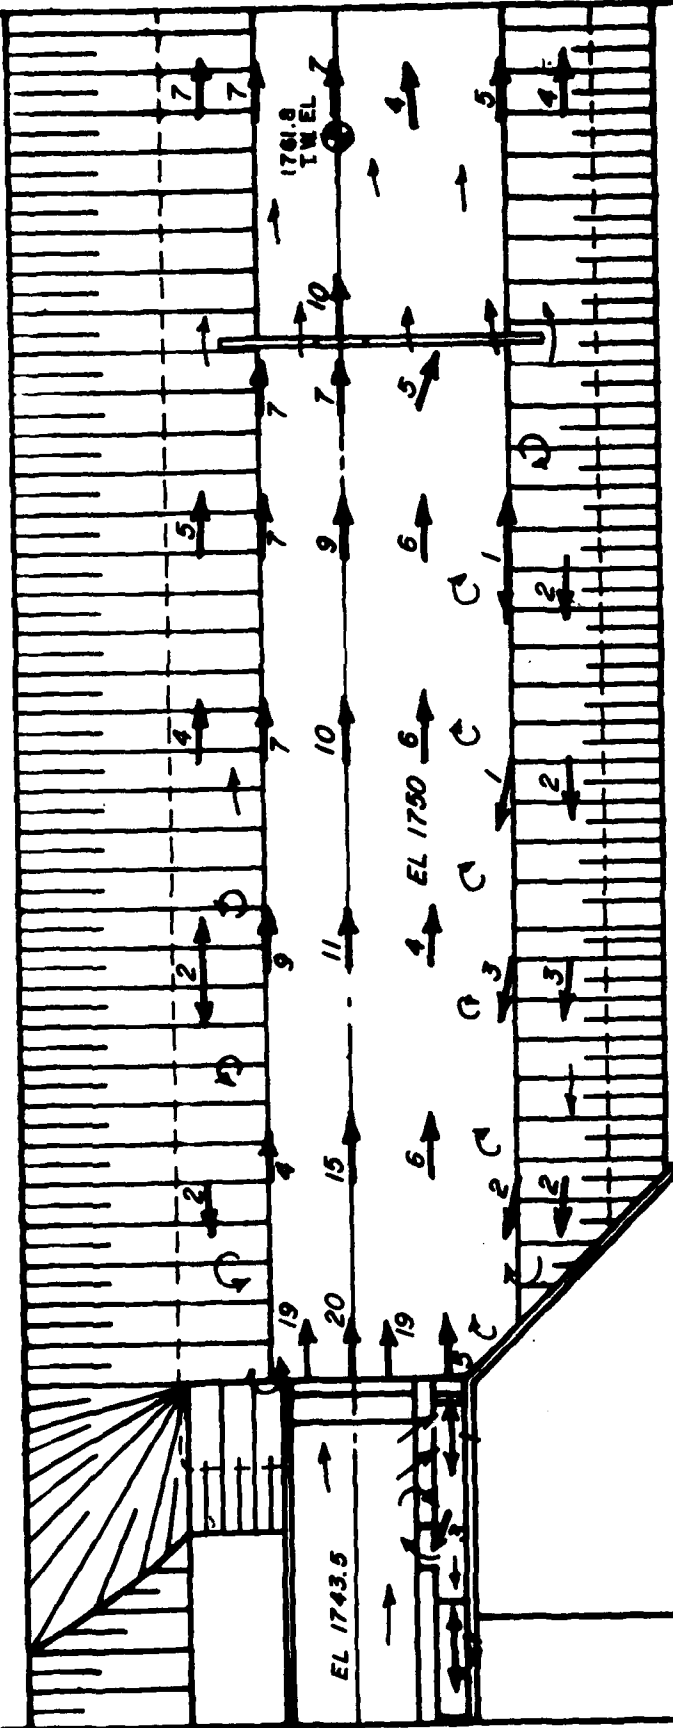
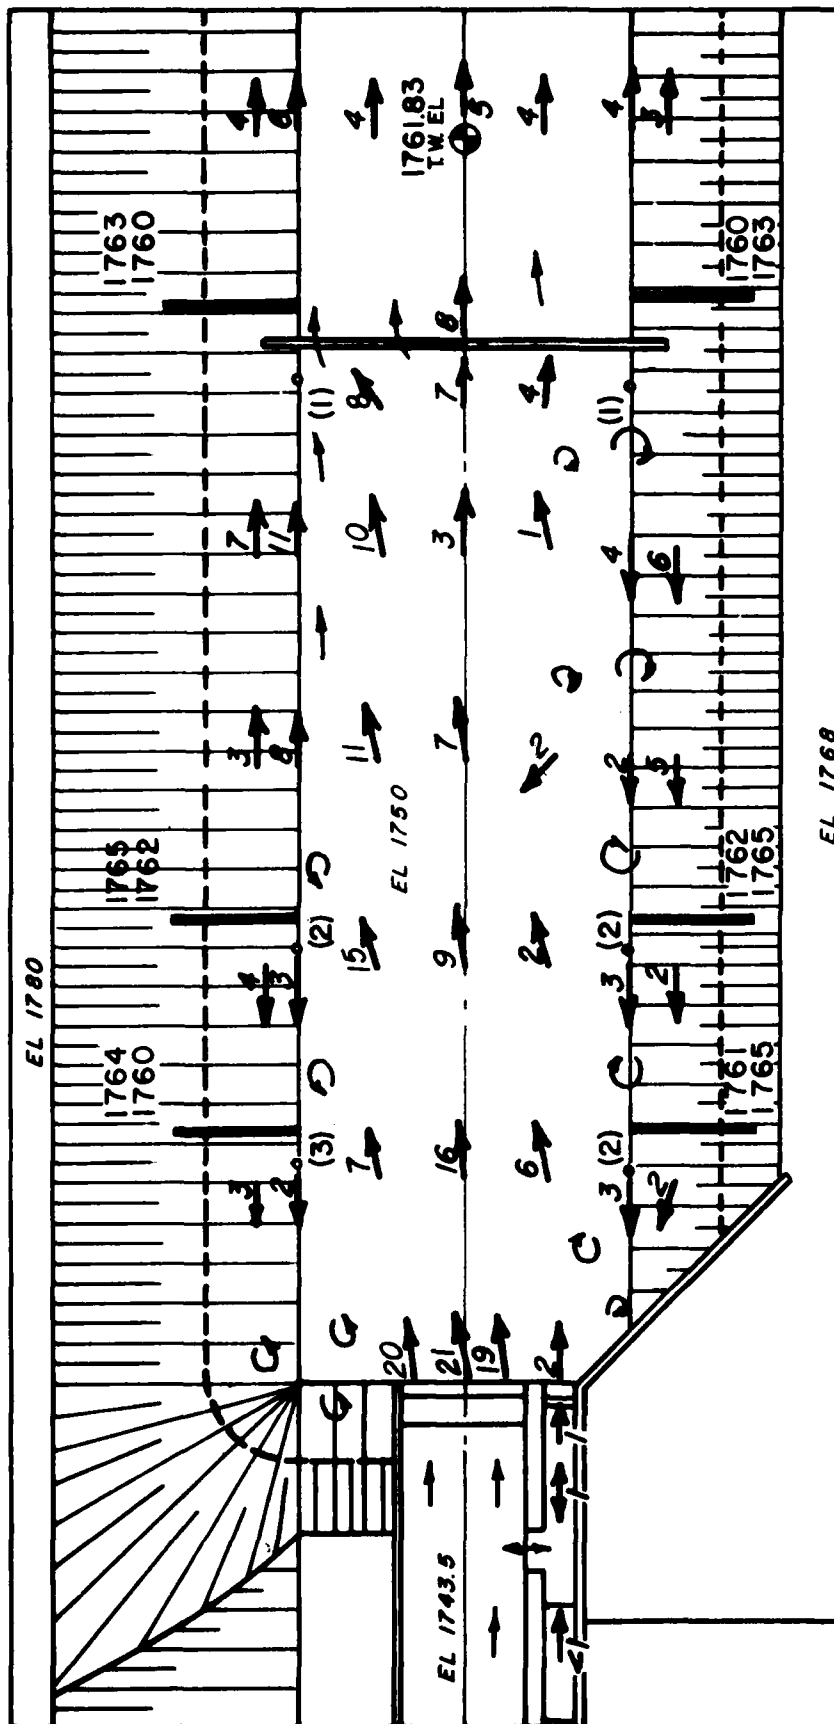
**VELOCITIES IN FPS, 2 FT ABOVE BOTTOM**

DISCHARGE 6100 CFS

POOL ELEVATION 1987.0
